Scanning Electron Microscopy to Establish the Marble Weathering Mechanism in the Alhambra of Granada (Spain)

SCANNING ELECTRON MICROSCOPY TO ESTABLISH THE MARBLE WEATHERING MECHANISM IN THE ALHAMBRA OF GRANADA (SPAIN)

M.A. Bello, L. Martín, A. Martín

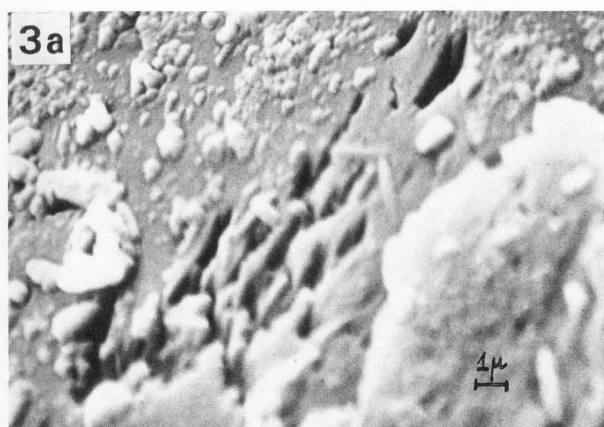
In Figure 3, we can observe that in the material from the Alhambra the 4 stages previously described also appear. The weathering morphology, specially that

of the last stage of the process, explains the remarkable increase in porosity with the weathering as well as the new formation of meso- and macro-pores.

Figure 3. Weathering stages on the white marble from the Alhambra. Bars = (a, c) 1 μm ; (b) 10 μm ; (d) 10 μm).

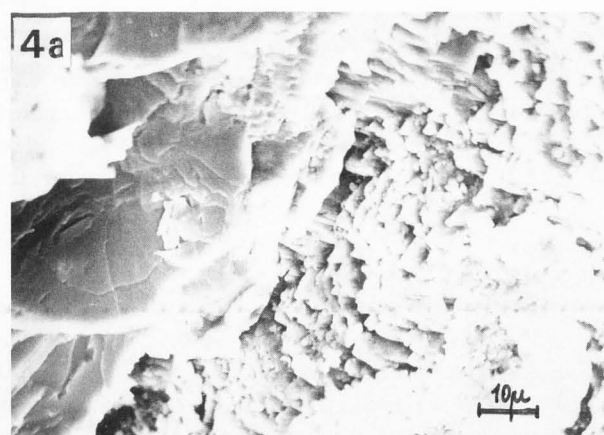
On the columns the main visual indicators of weathering are the fissures and cracks. However we must distinguish between a sunny zone, submitted to great thermic variations, in which the columns show an almost generalized important loss of material and disjunctions, and the non-sunny zone, in which the weathering manifestations are less important.

Figure 4 shows the more generalized microscopical morphology of the weathering for the materials from the sunny zone and we can consider, according to the stages established, that the materials are fundamentally in the third stage of the weathering process. Examples of all the stages can be found in all the columns.

Figure 4. Altered marble from the columns of the Patio de los leones Bars = (a, b) 10 μm .

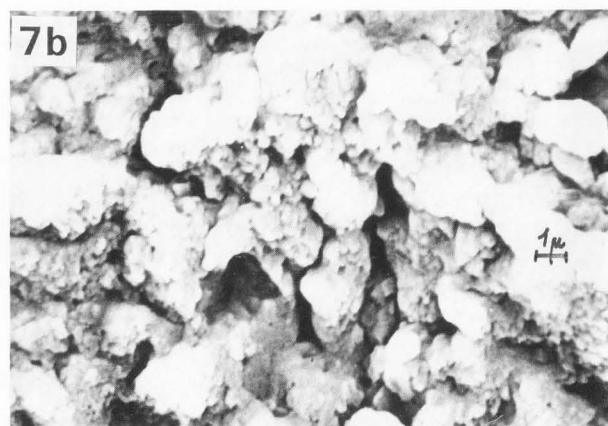
Annex rooms to the Patio de los leones. These are interior rooms and consequently the thermohygrometric variations are less important than outside; therefore, only some cracks and fissures are found as the more important visual indicators of weathering. The SEM study of a column sample reveals a general morphology (Figure 6) which corresponds to the initial stage of weathering. The apparition of small triangular holes on the matrix can be observed.

Figure 6. Altered marble from a column of the annex rooms to the Patio de los leones. Bar = 1 μm .

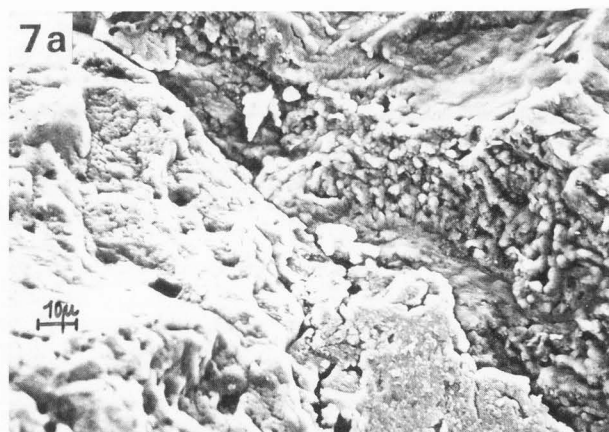
Arrayanes Palace. In this zone of the monument the loss of material is common, and specially in the "Patio de Comares"; likewise, the cracks and fissures are frequent. Figure 7 (which corresponds to an ancient remain of pavement) shows a material in advanced state of weathering (3rd-4th stage of the established process).

Figure 7. Altered marble from an ancient remain of pavement of the Arrayanes Palace. Bar = (a) 10 μm ; (b) 1 μm .

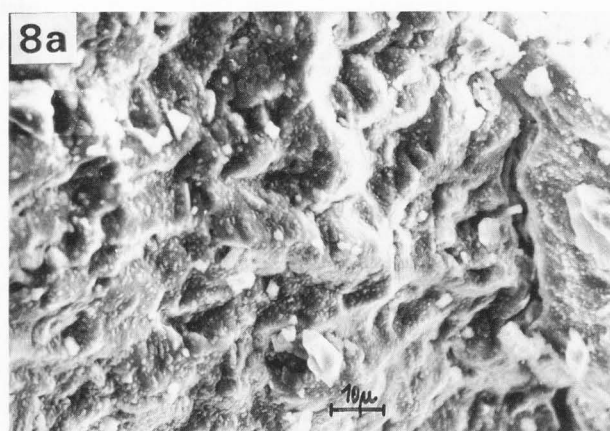
Lindaraja. On the columns of this zone, macroscopical indicators of weathering such as cracks, fissures and loss of material have been observed but less important than the Arrayanes Palace. The photomicrographs of Figure 8 show a material which can be considered between the second and third weathering stages.

Figure 8. Altered marble from the columns of Lindaraja. Bar = 10 μ m.
